ROTHESAY K-PARK PUBLIC CORRIDORS

RISK ASSESSMENT

Surveyed By	Rene J. Cormier	Date of Survey	November 29, 2012
-------------	-----------------	----------------	-------------------

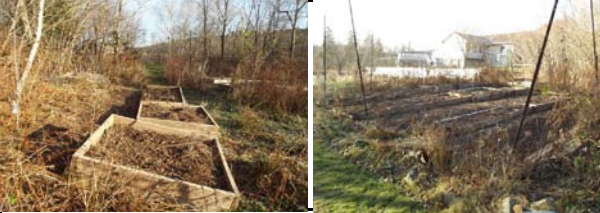
GPS SITE ID	RMS #	ADDRESS	DESCRIPTION	RISK	ASSESSMENT	RECOMMENDATION	PICTURE
	1	66 Park Drive	Garden Plot	Low	This feature limits access to the area should it be required however there is no visible liability concern.	None

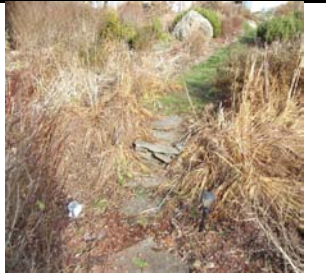
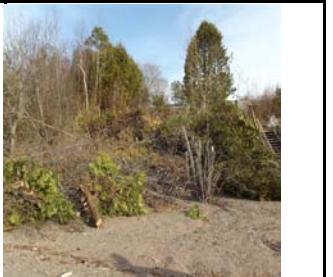
32	73 Elizabeth Parkway	Stairs and walkway to beach are not to code. Trees have recently been cut. For Sale sign on beach	High	The stairs lack proper handrails and guards which poses an exposure to bodily injury. Walkway is in poor condition and should be removed.	The guards on the stairway should be modified in such a way as to prevent passage of a spherical object of 100 mm (4 in) and that no horizontal component situated between 100 mm (4 in) and 900 mm (36 in) from the floor may permit climbing.

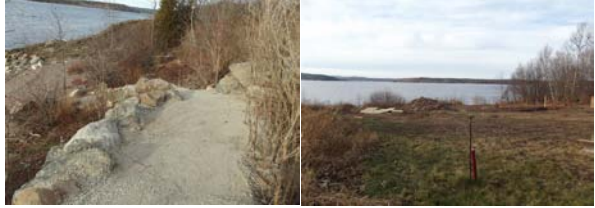
39	61 Elizabeth Parkway	Walking path to beach under construction lacks proper handrails. Land extension on to corridor.	High	It is assumed there is an easement agreement in place for this new building under construction.	The walkway should be equipped with handrails.

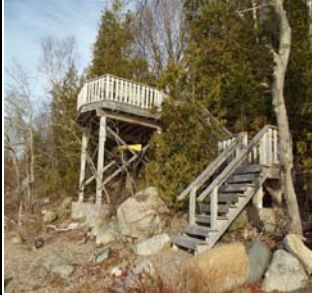
42	57 Elizabeth Parkway	Viewing deck and stairs not to code.	High	The deck does not appear to be built to code. The railings should be 42" high. The stairs are not built to code. There is an extension cord running from the house to the deck which poses a tripping hazard and is not to code.	The guards on the stairway should be modified in such a way as to prevent passage of a spherical object of 100 mm (4 in) and that no horizontal component situated between 100 mm (4 in) and 900 mm (36 in) from the floor may permit climbing. Remove extension cord.

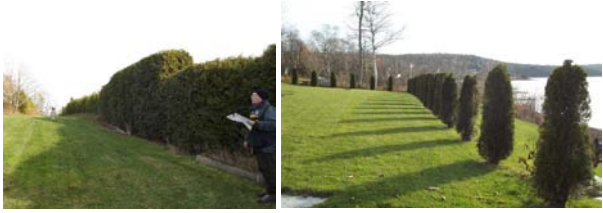
44	55 Elizabeth Parkway	Hedge and land extension	Low	Hedges are nicely groomed and cause no apparent liability hazards. Land has been extended onto corridor but well cared for.	None

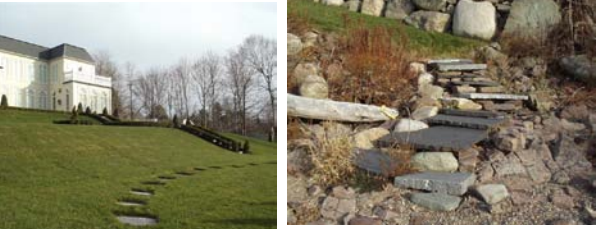
45	55 Elizabeth Parkway	Garden with planter possibly on corridor. Stairs to beach.	High	The garden with planter is well arranged however the stairs to the beach present a liability hazard.	The stairs should be removed.

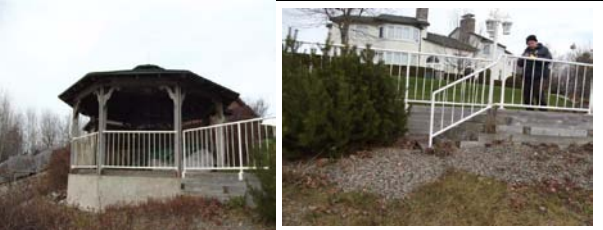
48	21 Elizabeth Parkway	Gazebo and stairs to beach.	Low	Appears well built and poses no apparent liability concerns.	None

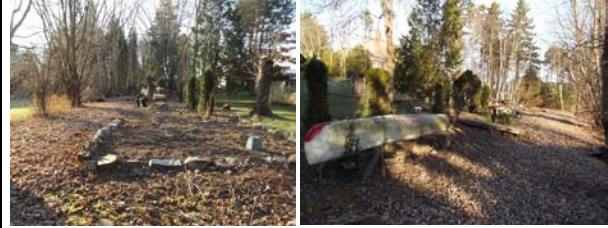
50	36 Holiday Drive	Garden plot and canoe storage	Low	Obstruction but no apparent liability hazards.	None

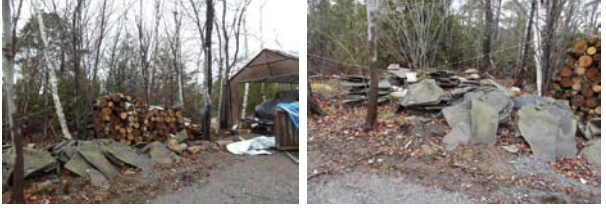
57C	3 Princess Place	Wood pile and slate rock pile	Low	Fire wood and slate rock are piled on corridor property.	None

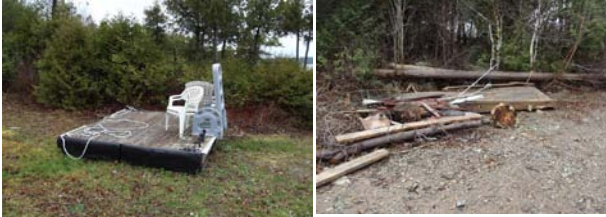
58	4 Sunset Lane	Floating wharf and debris.	Medium	A wharf stored on town property and in season accessible from town property poses a liability risk for the Town. Debris poses a liability hazard.	Debris should be removed.
